Beth Shalom Rain Garden Expansion

mostcenter.org/casestories

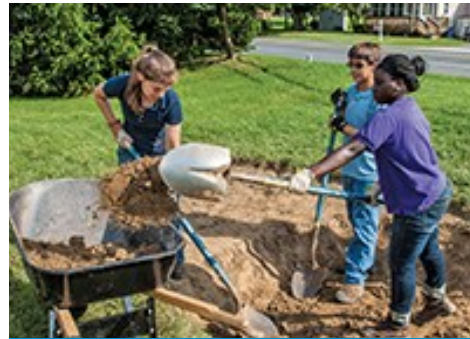
The raingarden under construction

The Howard County READY (Restoring the Environment and Developing Youth) Program – which provides summer employment for high school and college students – helped retrofit Beth Shalom's rain garden. Two-foot wide auger holes were drilled in the ground and filled with stone to facilitate greater infiltration. The garden was also expanded to handle greater stormwater volumes, and drainage issues have been completely resolved. Ongoing maintenance will be provided by READY's Garden Maintenance Program, which will visit the site 4-6 times per year.

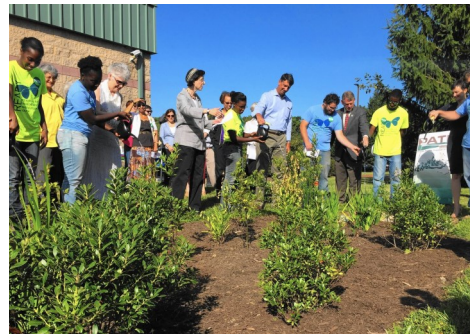
The new raingarden alleviated flooding .
Photo Credit: The READY program
